PD TEESPORT LTD

CHANNEL SHOALING NOTE

Issued by the Harbour Master on 27th November 2023

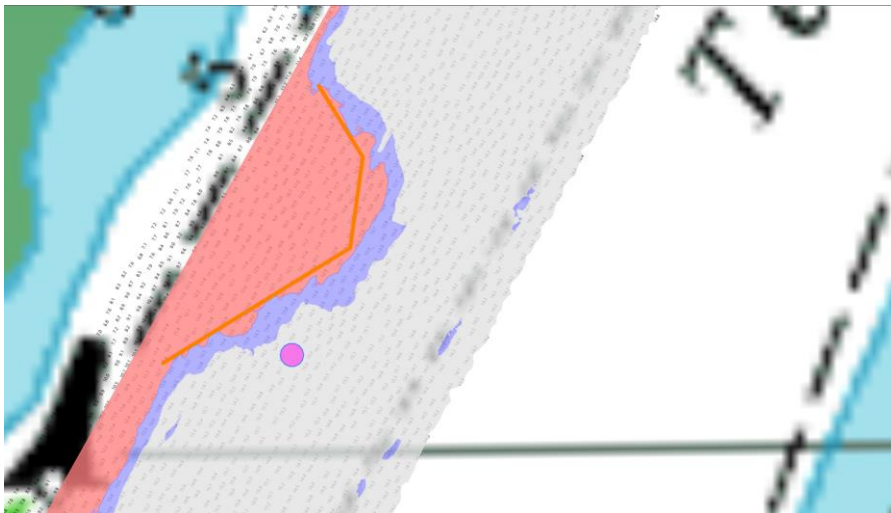
A bank slippage has occurred between No. 9 and No. 11 Buoys with depths of less than 12.5m up to 56m into the channel. The limit of this area of shoaling can be shown by a line joining the following positions:

A winker buoy has been deployed at the extremities of the bank slippage area, to mark the area of reduced depth.

The winker buoy will remain in place for the duration of the dredging.

With the winker buoy in place the following draught formulae may be used:
